The Triplex BioValsalva Prostheses To Reconstruct the Aortic Valve and the Aortic Root

ABSTRACT: The Bentall procedure introduced in 1968 represents an undisputed cure to treat multiple pathologies involving the aortic valve and the ascending thoracic aorta. Over the years, multiple modifications have been introduced as well as a standardized approach to the operation with the goal to prevent long-term adverse events. The BioValsalva prosthesis provides a novel manner to more efficiently reconstruct the aortic valve together with the anatomy of the aortic root with the implantation of a valved conduit. This prosthesis comprises three sections: the collar supporting the valve; the skirt mimicking the Valsalva, which is suitable for the anastomoses with the coronary arteries; and the main body of the graft, which is designed to replace the ascending aorta. The BioValsalva prosthesis allows the Bentall operation to be used in patients whose aortic valve cannot be spared.

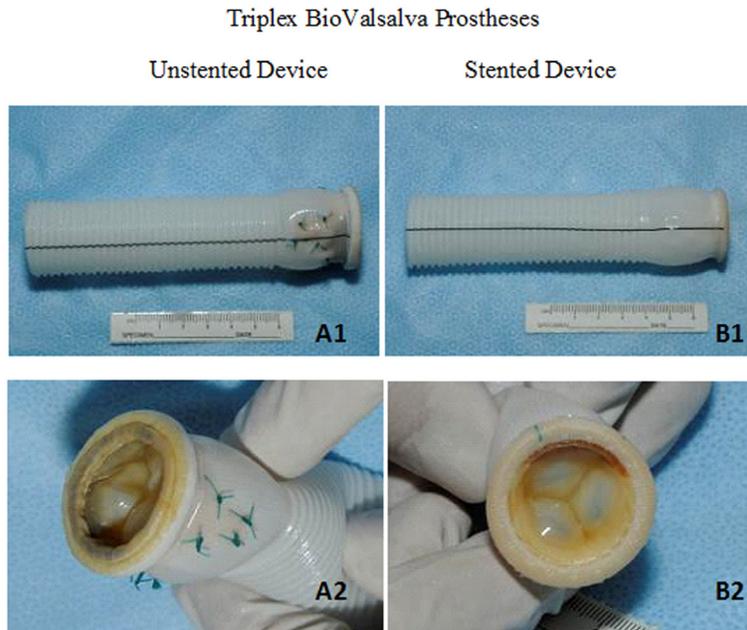
FIG. 1: Gross observation of the BioValsalva prostheses. Each device (A1, B1) holds three sections, the collar supporting the valve, the Valsalva and the skirt. The Valsalva is belly shaped to anastomose the coronary conduit with reduced tension whereas the skirt is crimped perpendicularly to the blood flow. The valves are bioprostheses made of porcine aortic valve. In the unstented device, the porcine valve is scalloped and immobilized with sutures attached to the Valsalva (A2) in addition to the fixation to the collar. In the stented device the valve is only attached at the collar (B2).

The BioValsalva prostheses possessed the elements necessary to perform the Bentall operation with a valved conduit: the three sections of the devices were well differentiated (Figures 1 and 2). The porcine bioprotheses, either unstented or stented, were fixed at the collar. The second section, by the name of the skirt, was belly shaped to permit the anastomosis of the coronary arteries without tension. It mimicked the Valsalva and thus could reduce the risk of false aneurysms at the suture lines of the coronary conduits. The third section was defined as the body to serve as the outflow of the device. The crimps were perpendicular to the blood flow. This section could be trimmed by the surgeon to fit in the site of implantation. The anastomoses between the different sections were regular without any

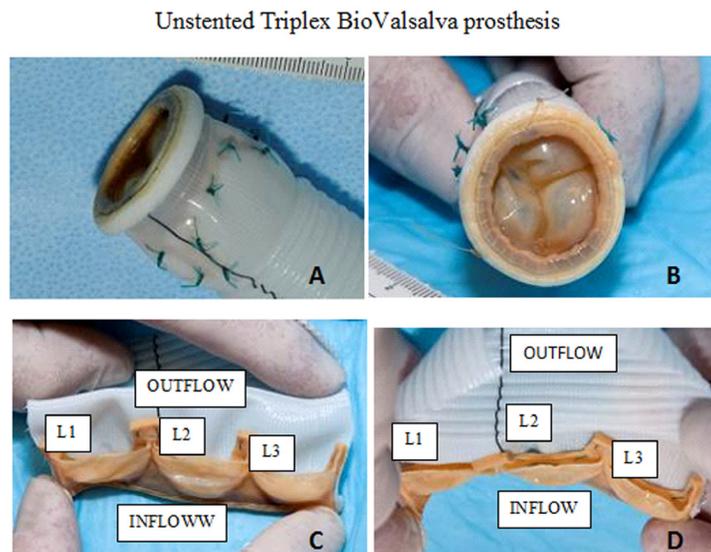
FIG. 2: Gross observation of the porcine valve in the unstented BioValsalva device. The bioprosthesis that is scalloped in the aorta is anastomosed to the collar and sutured to the Valsalva (A). The leaflets show a good coaptation (B) and the semilunar leaflets or cusps are attached to the aorta and are flawless. They can be identified as left coronary (L1), non-coronary (L2) and right coronary (L3).

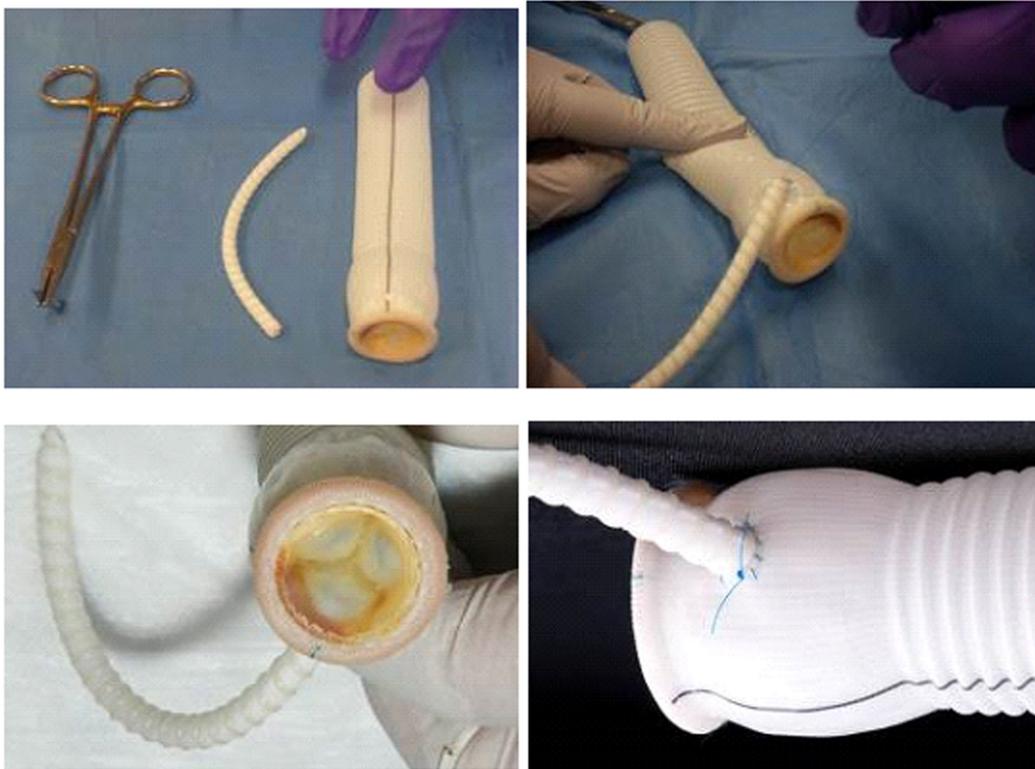
Suturing a coronary conduit to the stented Inplex BioValsalva prosthesis

FIG. 3: Suturing a coronary conduit to the Valsalva to mimic the anastomosis of a coronary graft. A 4-mm spirally supported polyester graft is anastomosed with a 6.0 monofilament polypropylene suture after opening a 4-mm-diameter orifice in the Valsalva (A). The anastomosis can be completed (B), without any adverse effect on the leaflet coaptation. In addition (C) no fraying of the fabric can be seen.

The suture of a coronary polyester conduit was easily performed by means of a monofilament polypropylene suture and the anastomosis did not show any fraying of the structure. The perforation of the body by means of a trocar to mimic the degassing showed some mild fraying but the hole did not stretch. Such a hole can be repaired by a single suture stitch (Figures 3-5). The valves were flawless as it was confirmed in Micro CT Scan observation (Figure 6). A good placement of the commissures of the leaflets was observed with a complete juxtaposition along their entire length. These commissures

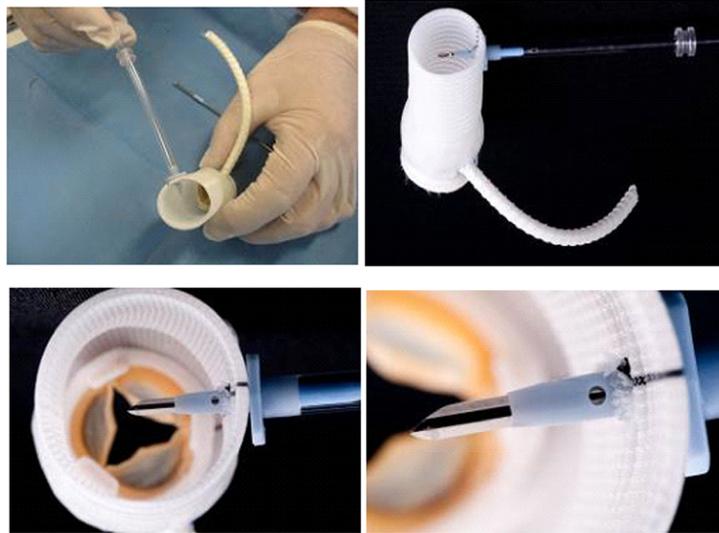
Inserting the trocar for simulation of degassing

FIG. 4: Insertion of trocar through the wall of the skirt of the stented device to permit complete degassing of the extracorporeal circuit before restoring the blood flow (A, B). The mild trauma caused by this procedure can be revised by means of a simple suturing after the trocar is pulled out (C, D).

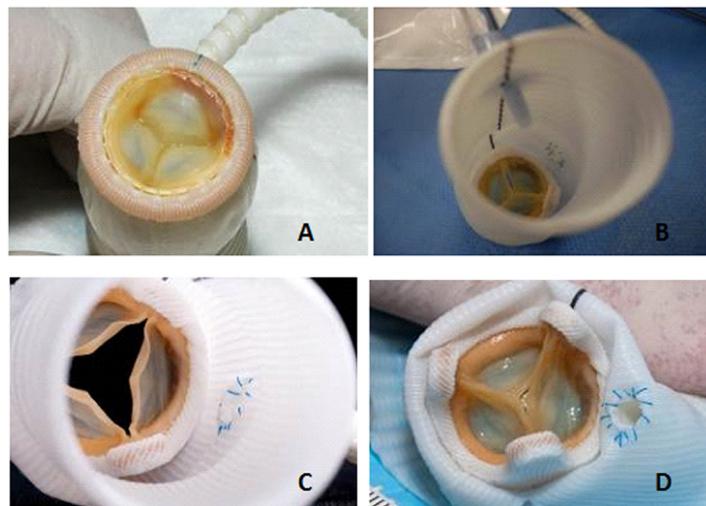
Anastomosis of the coronary conduit

FIG. 5: Anastomosis of a coronary conduit to the stented BioValsalva. The inflow shows a perfect coaptation of the three leaflets (A). The outflows together with the ostia of the coronary conduit are observed within the Valsalva (B). The valve can open as observed on the outflow side without fraying of the fabric at the ostia with the coronary conduit (C). A more detailed observation confirms the feasibility of the procedure (D).

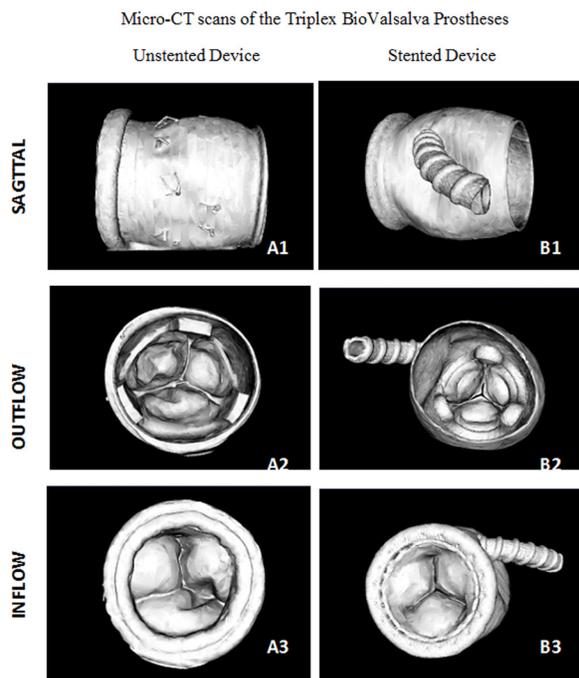
FIG. 6: Micro CT scan observation of the stented device after suturing a coronary graft (left) and the unstented device (right). The coronary branch is anastomosed to the Valsalva of the first one (A1), whereas the scalloped aortic valve is sutured to the Valsalva (B1). The coaptations at the inflow of the leaflets of both valves are adequate in both devices (A2, B2). The observations of the outflow are similar (A3, B3).

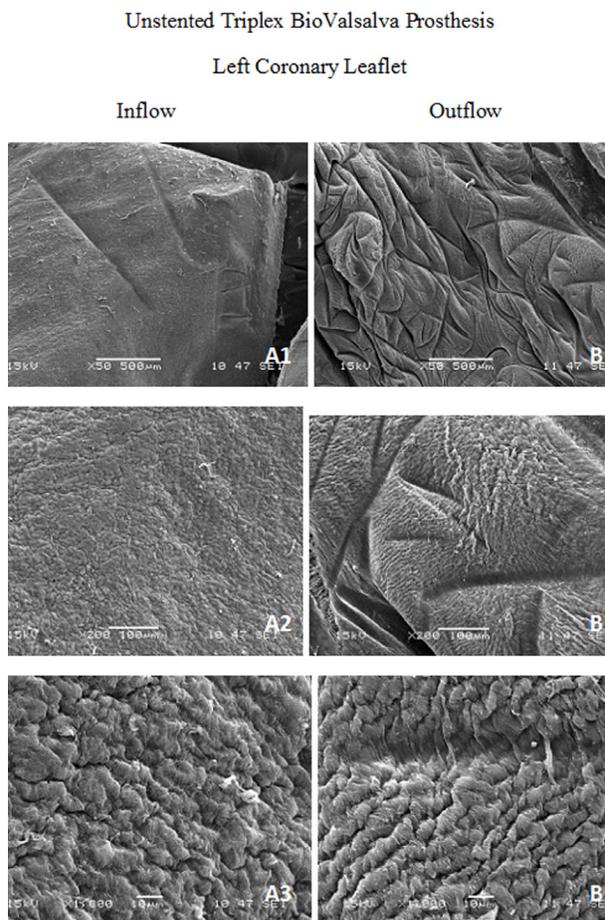
FIG. 7: Leaflet 1 in the unstented BioValsalva device. The inflow is smooth with a corrugated smooth surface with minor irregularities (A1). The subendothelial layer is continuous and devoid of endothelial cells previously eliminated during the processing. The shallow undulations follows the underneath structures of the waviness of the collagen and elastic fibers (A2,A3). The outflow shows an irregularity undulated surface with prints resulting from the handling of the valve during suturing (B1). The surface is mildly damaged with undulations following the structures of the underlying collagen bundles in addition to the corrugations at the systole (B2). At higher magnification, the subendothelial layer is shown continuous and regular (B3).

lagen bundles. The outflow (fibrosa) was frequently somewhat crimped or corrugated. This crimped configuration corresponded to the fixation during the systole as the result of the contraction of the underneath structure of the collagen wavy crimps. The few shallow fractures on the surface were probably an artifact caused by the flattening of the sample of the specimen on the stub. The marks of the surgical tools used to suture the valve to the skirt were evidenced. This trauma was only a surface phenomenon (Figures 7–9).

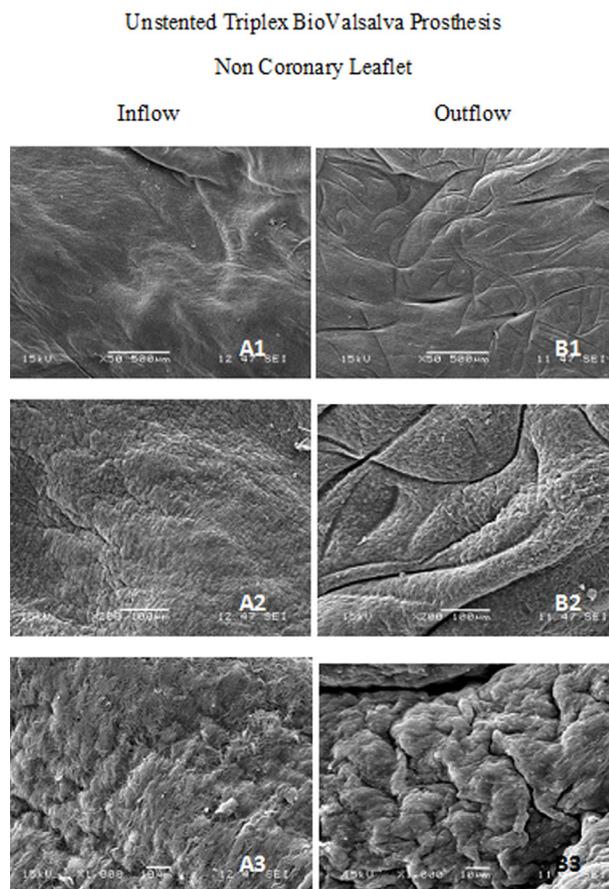
FIG. 8: Non-coronary leaflet in the unstented BioValsalva. The inflow side does not show the same smoothness (A1), but the subendothelium is well preserved and continuous (A2); some ghost cells are suspected (A3). The outflow shows many prints of surgical tools that applied pressure on the mildly corrugated valve (B1). The fractures in the subendothelial were aggravated by the immobilization of the tissues on the stub for observation in SEM (B2). The underneath bundles of collagen show waviness. The fibers are well differentiated (B3).

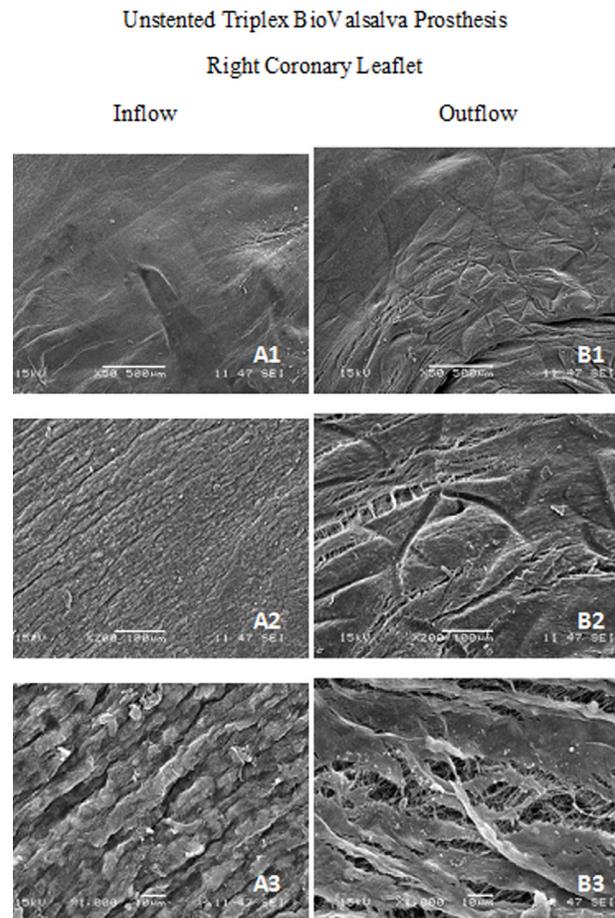
FIG. 9: Right coronary leaflet in the unstented BioValsalva. The inflow side is smooth but not flat and holds local belly configurations (A1). The subendothelial layer is continuous without any fracture (A2, A3). The outflow side shows a corrugated structure with longitudinal disruptions in the direction of the corrugations and the marks of surgical tools (B1, B2). The collagen bundles are visible underneath the disruption in the subendothelium (B3).

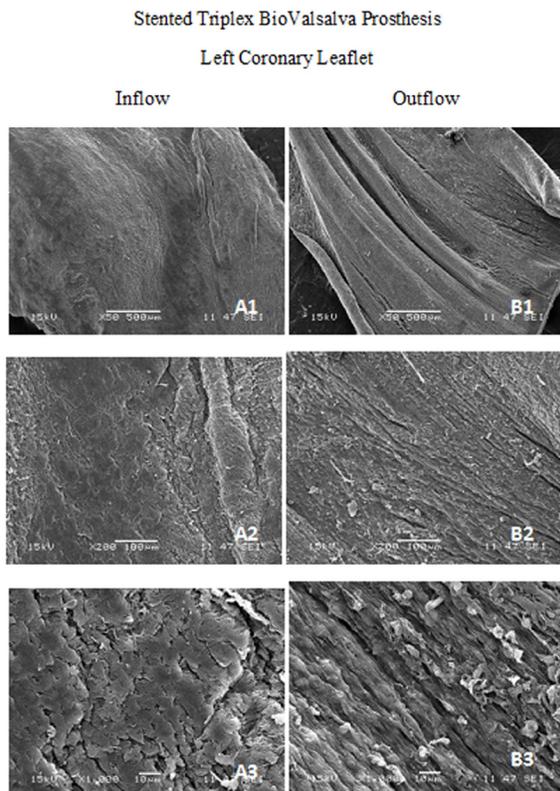
FIG. 10: Leaflet 1 in the stented BioValsalva device. The inflow is smooth with smooth, low-profile belly undulation (A1). The subendothelial layer is well preserved and follows the morphology of the underneath waviness of the collagen bundles (A2). The outflow is waved with disruptions parallel to the folds (B1). The fissures are aggravated by the immobilization of the sample on the stub after drying (B2). The subendothelial layer splits permit to locally identify the underlying fibers. It holds ghost endothelial cells (B3).

The flawed surface of the leaflets of the stented BioValsalva showed a similar morphology, but there was no mark of the surgical tweezers on their surfaces (Figures 10–12).

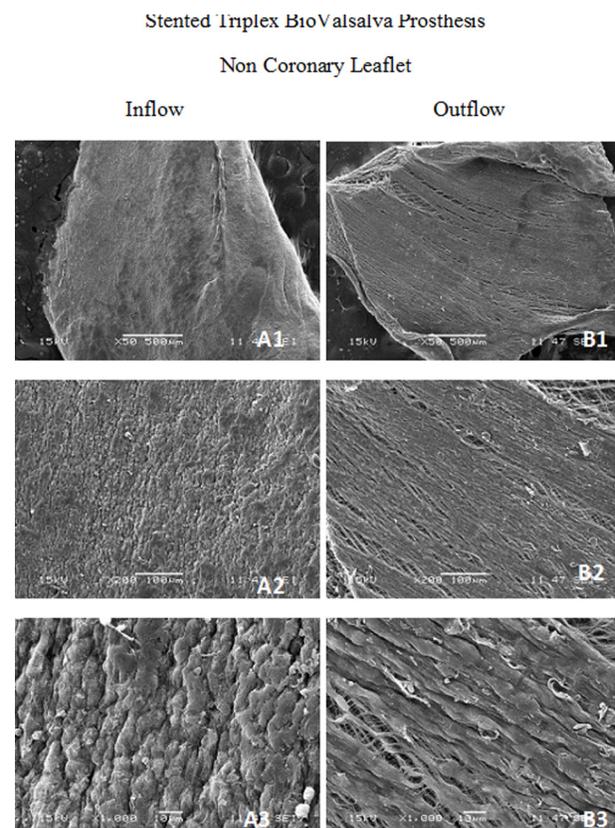
FIG. 11: Non coronary leaflet in the stented BioValsalva device. The inflow shows a smooth and continuous subendothelial surface with some moderately low-profile swollen areas (A1). There is no disruption in this subendothelial layer (A2) whose microstructure follows the underneath structure of the collagen bundles (A3). The outflow holds a major corrugation with longitudinal splits in the subendothelial layer parallel to this corrugation (B1). These fissures permit to visualize the underlying bundles of collagen (B2). The ghosts of endothelial cells from the endothelium are visible (B3).

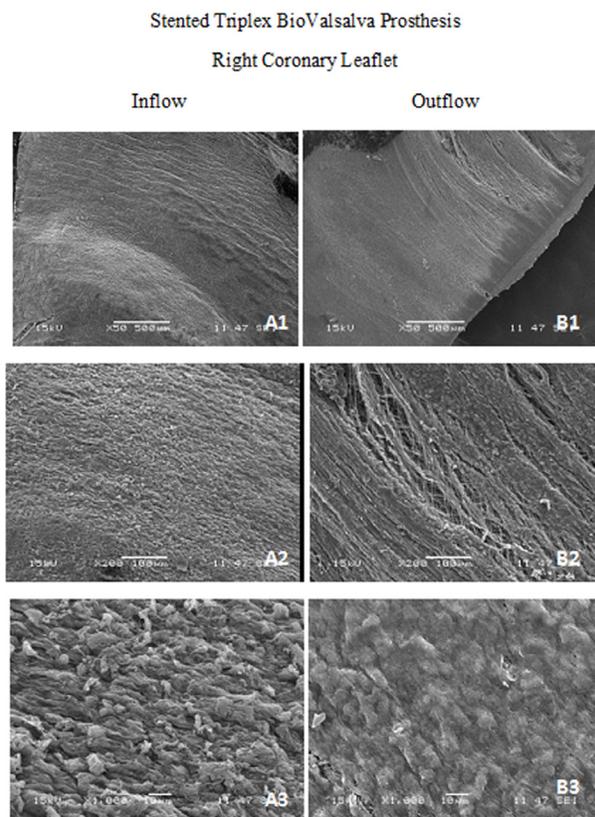
FIG. 12: Right coronary leaflet in the stented BioValsalva device. The smoothness of the outflow shows a low-profile belly structure in the vicinity of the undulations of the surface (A1). The flow surface shows some desquamation of the ghost cells of the endothelium (A2, A3). The outflow of the leaflet was locally corrugated and mostly flat (B1). The fractures in the subendothelial layer make the underlying structures of collagen bundles visible (B2). Otherwise, the surface is smooth with ghost of endothelial cells (B3).

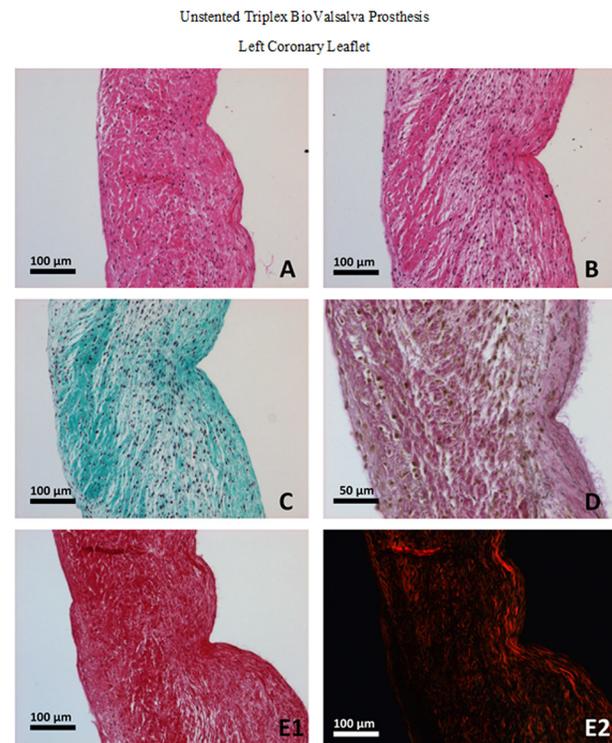
FIG. 13: Light microscopy photomicrographs of the left coronary leaflet of the unstented BioValsalva device. They are shown from the inflow to the outflow: the ventricularis, the spongiosa and the fibrosa. Its thickness is variable i.e., between 200 μm and 700 μm . The ventricularis, i.e., the inflow, shows bundles of collagen and elastin not organized in a specific direction. The fibrosa is the outflow, whose thickness ranges between 150 μm and 250 μm , holds large bundles of collagen that are oriented predominantly in the circumferential direction of the leaflet. It explains the frequent presence of corrugations observed in scanning electron microscopy. The fibrosa is shown as a buffer between the ventricularis and the fibrosa. It holds loosely arranged collagen and elastin fibers within the glycoaminoglycans. The endothelial cells were destroyed during the processing and thus only ghosts of endothelial cells can be observed. The subendothelium is intact without any rupture, nor fragmentation. An abundant cellularity is visible in the ventricularis and the fibrosa.

in the unstented prosthesis were similar to those in the stented prosthesis (Figures 13–18).

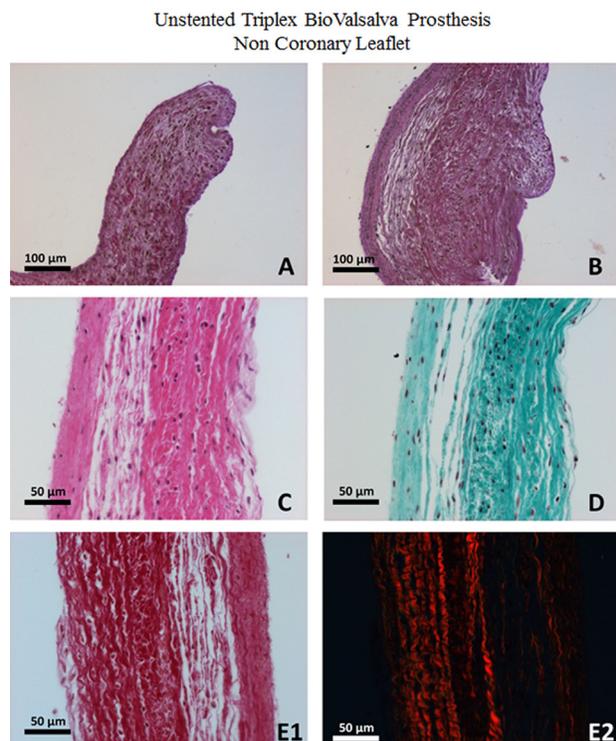
FIG. 14: Light microscopy photomicrographs of the non-coronary leaflet of the unstented BioValsalva device at its coaptation area. The spongiosa is thinner than in Figure 13. The outflow surface, i.e., the fibrosa, is highly corrugated; this is an abundant amount of underneath collagen fibers. The outflow surface, i.e., the ventricularis, is thinner than the fibrosa and holds a large amount of collagen fibers. In both sites, the collagen bundles are parallel to the flow surface. The endothelium of both inflow and outflow holds only some ghosts of endothelial cells. The subendothelium is intact whereas the valvular interstitial cells are dispersed in the 3 layers of the structures.

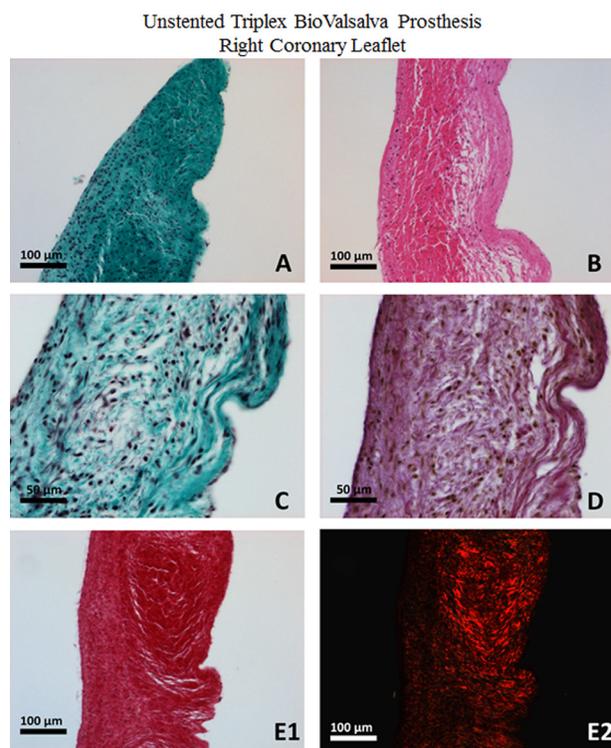
FIG. 15: Light microscopy photomicrographs of the right coronary leaflet of the unstented BioValsalva device at its coaptation area. The profile of the fibrosa, which is thinner than the ventricularis, is highly corrugated, and the collagen bundles are oriented in various directions. The spongiosa is well identified. The valvular interstitial cells are dispersed in the ventricularis and the fibrosa, but scarce in the fibrosa.

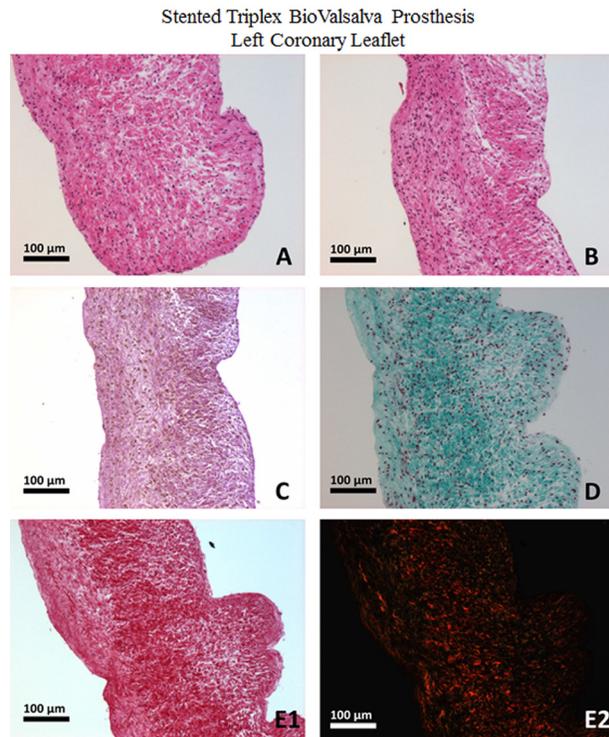
FIG. 16: Light microscopy of the left coronary leaflet of the stented BioValsalva device in the coaptation area. The spongiosa is almost absent, and the flow surface of the fibrosa is highly corrugated. The collagen bundles are oriented circumferentially. No endothelium is left, but the subendothelium layer is intact. The valvular interstitial cells are abundant throughout the cross-section.

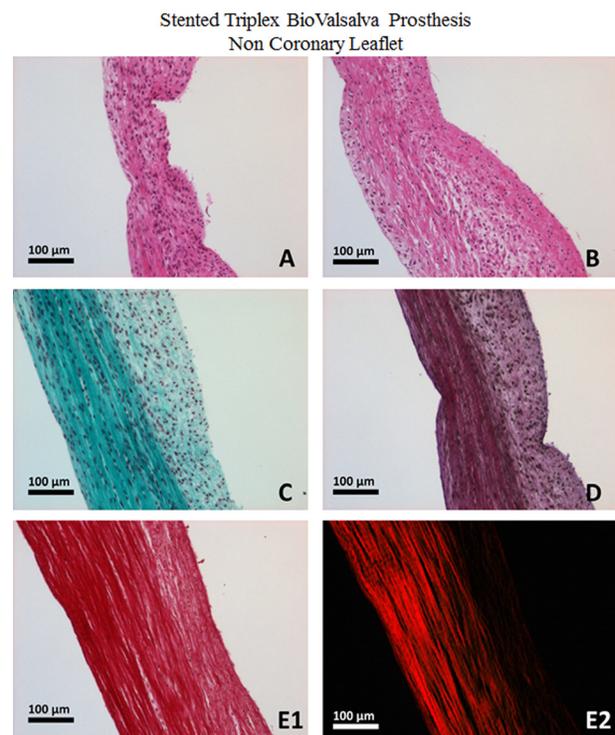
FIG. 17: Light microscopy of the non-coronary leaflet of the stented BioValsalva device in the coaptation area. The fibrosa is highly corrugated and shows various thicknesses. The spongiosa is almost absent. The ventricularis is made of stretched collagen and elastin fibers. The interstitial cells are particularly abundant in the fibrosa. There is no endothelium left, but the subendothelia are well preserved.

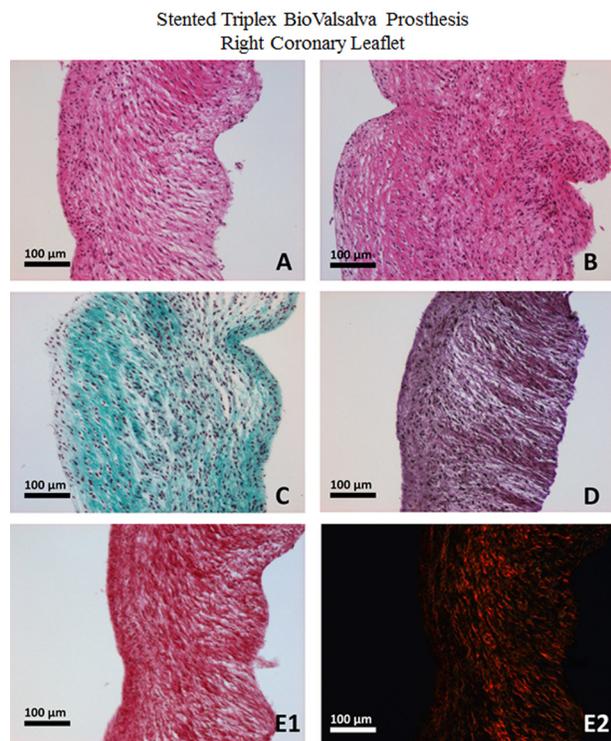
FIG. 18: Light microscopy of the right coronary leaflet of the stented BioValsalva device. The flow surface of the fibrosa is highly corrugated because of the underneath collagen bundles. The spongiosa is ill defined, whereas the collagen fibers of the ventricularis are circumferentially oriented. Abundant colonies of valvular interstitial cells are dispersed throughout the different layers of the leaflet. No endothelium is left on both the inflow and the outflow. The subendothelial layers are intact.

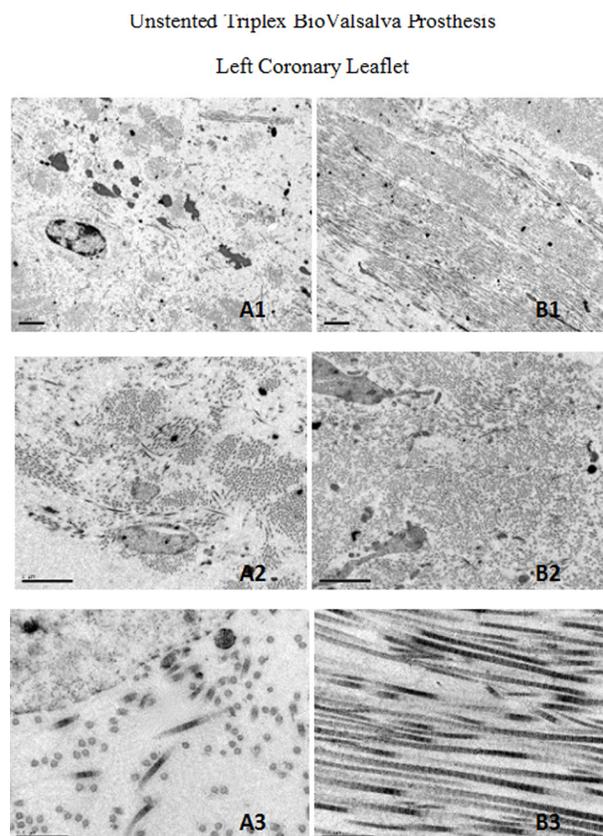
FIG. 19: Transmission electron microscopy of the left coronary leaflet of the unstented BioValsalva device. On the left is an area of scarce collagen content in the spongiosa. The cells are well preserved; no halo is visible either inside or in the vicinity. Some elastin fibers are noticeable. The collagen bundles are very loosely dispersed. Each filament is well individualized and a regular banding is suspected. Meanwhile, the collagen bundles of the ventricularis and the fibrosa lie as parallel assemblages of individual fibers. Each fiber shows a regular bonding characteristic.

filaments was always visible and clearly identified on every single collagen fibril (Figures 19–24).

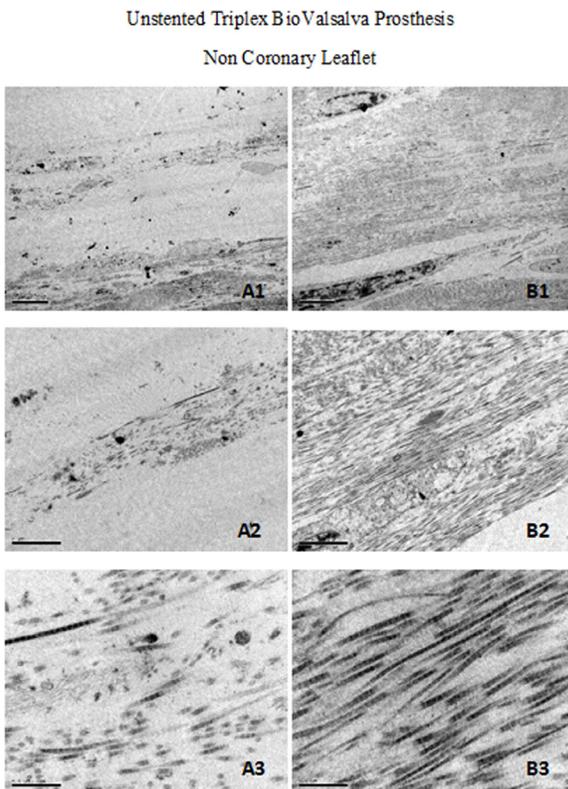
FIG. 20: Transmission electron microscopy of the non-coronary leaflet of the unstented BioValsalva device. The collagen content of the microphotographs of the left is highly dispersed in the spongiosa. The fibrils hold the regular banding characteristic of collagen. The elastin filaments are very scarce. The collagen bundles are abundant in the ventricularis and the fibrosa. The fibers are, individually and in parallel, assembled in bundles surrounding interstitial cells. The banding of the collagen filaments is perfectly regular and characteristic.

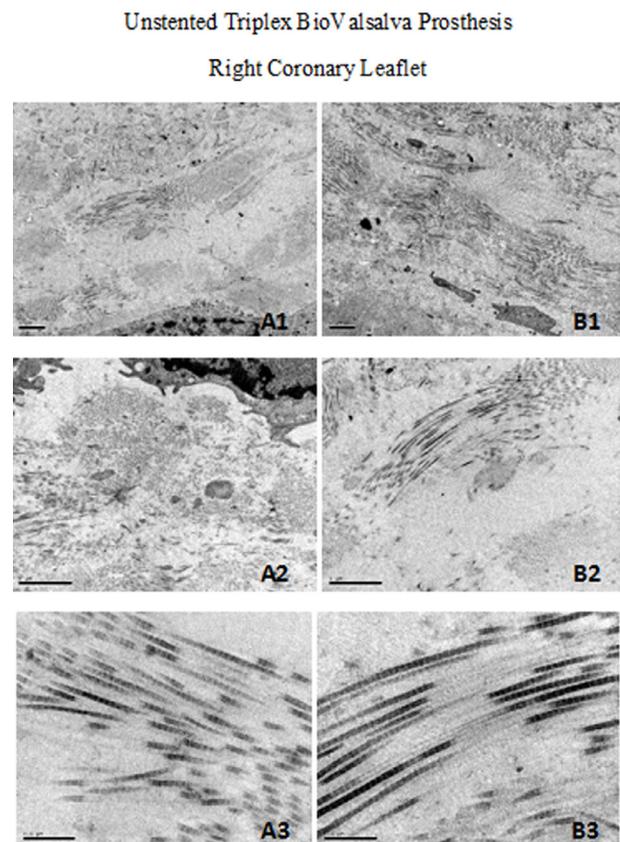
FIG. 21: Transmission of the right coronary leaflet of the unstented BioValsalva device. The collagen content of the microphotographs of the left is poorly organized and highly dispersed. The ventricular interstitial cells are well preserved and the filaments of collagen hold the characteristic banding. The collagen content in the other layers, i.e., ventricularis and fibrosa, is more abundant, but the content of the collagen bundles was limited. The filaments are perfectly individualized, showing characteristic banding.

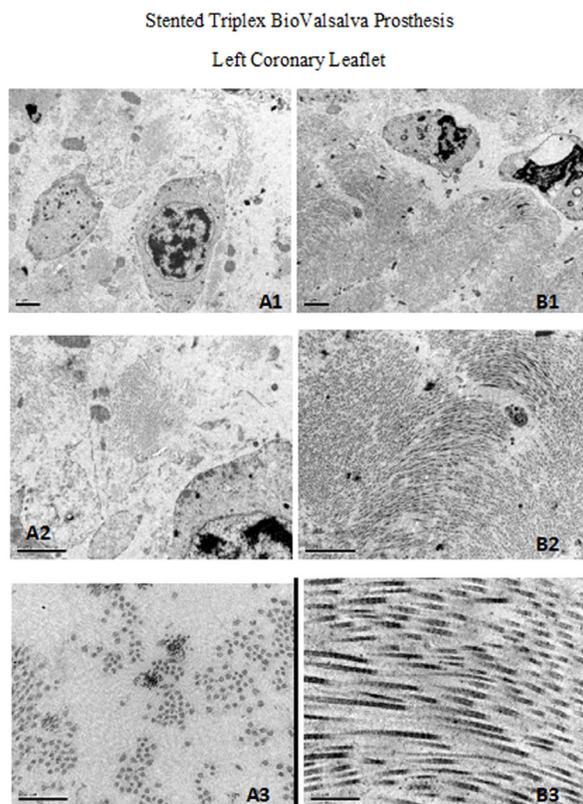
FIG. 22: Transmission electron microscopy of the left coronary leaflet of the stented BioValsalva. The microphotographs of the left show a highly cellularized area in the spongiosa with dispersed filaments of collagen and rare elastin filaments. The cross-section of the poorly assembled bundles of collagen confirms that the individual filaments are perfectly individualized. In the areas of denser collagen of the ventricularis and the fibrosa, the cellularity is well preserved. The bundles of collagen that surround the interstitial cells show alternate longitudinal views and cross-sections, i.e., waviness. The filaments are perfectly individualized and show the regular pattern typical of collagen.

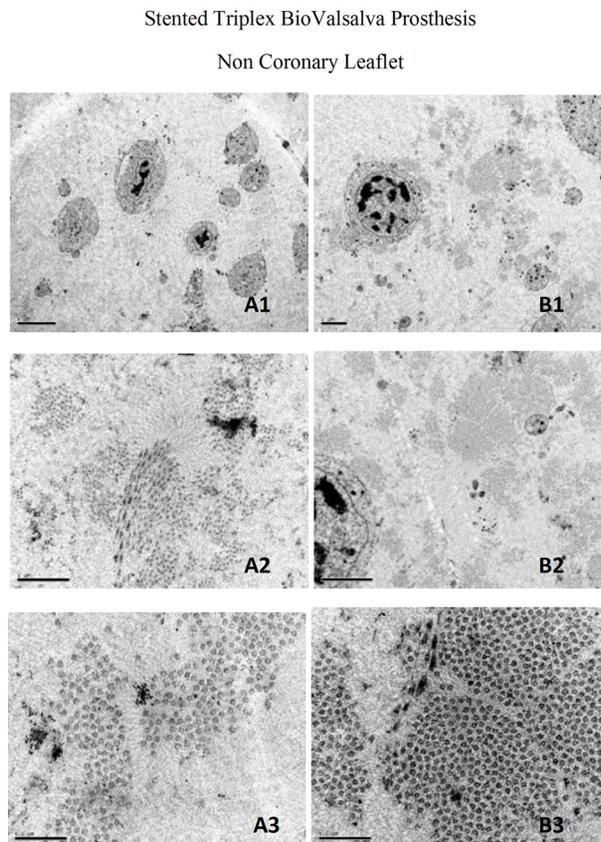
FIG. 23: Transmission electron microscopy of the non-coronary leaflet of the stented BioValsalva. The microphotographs of the left show a highly cellularized content dispersed in the glucosaminoglycans in the spongiosa. The filaments of collagen are loosely assembled in bundles. Some scarce elastin filaments can be seen as well. The microphotographs of the right show a section with some interstitial cells surrounded by bundles of collagen filaments well individualized. Some scarce filaments of elastin are visible as well.

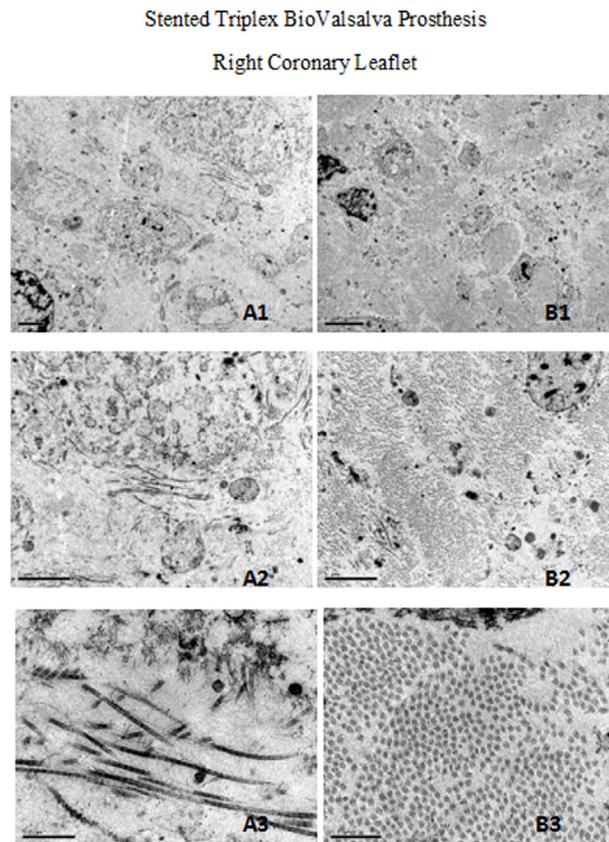
FIG. 24: Transmission electron microscopy of the right coronary leaflet of the stented BioValsalva. The micrographs of the left show a very limited collagen content in the spongiosa. There are numerous ventricular interstitial cells and dispersed filaments of elastin and collagen. The banding of the collagen filaments is perfectly regular. The microphotographs of the right show a dense assemblage of collagen bundles incorporating scarce elastin filaments and surrounding ventricular interstitial cells. The filaments of collagen were well individualized as seen in cross-section.

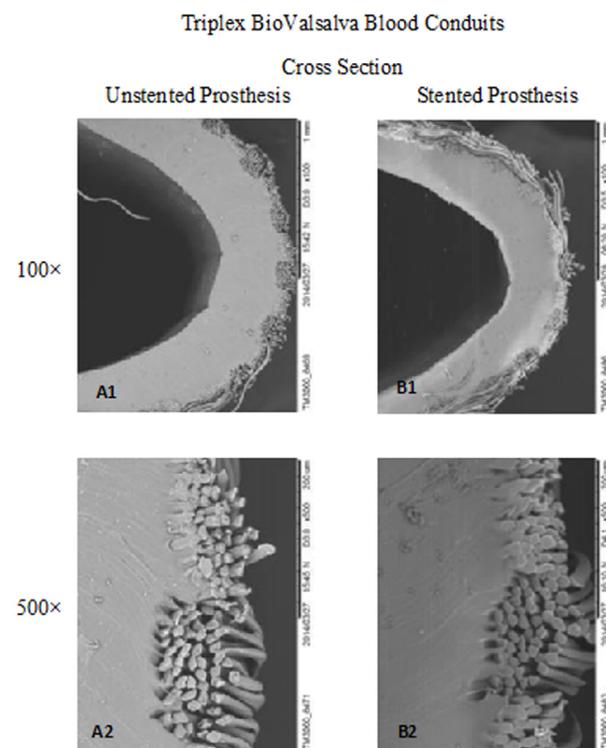
FIG. 25: SEM microphotographs of the cross-section of the BioValsalva devices. Both the unstented and the stented prostheses show a thin woven fabric (inside) to be exposed to the blood flow externally impregnated with a thermoplastic polymer, coated with a Teflon film (outside). The thermoplastic polymer is strongly anchored to the fabric and penetrates deeply in the wall of the polyester structure filling and the void spaces between the yarns.

The scanning electron microscopy photos of the blood conduits taken before eliminating the Triplex coating confirmed the complete imperviousness of the prosthetic walls in the different sections (Figure

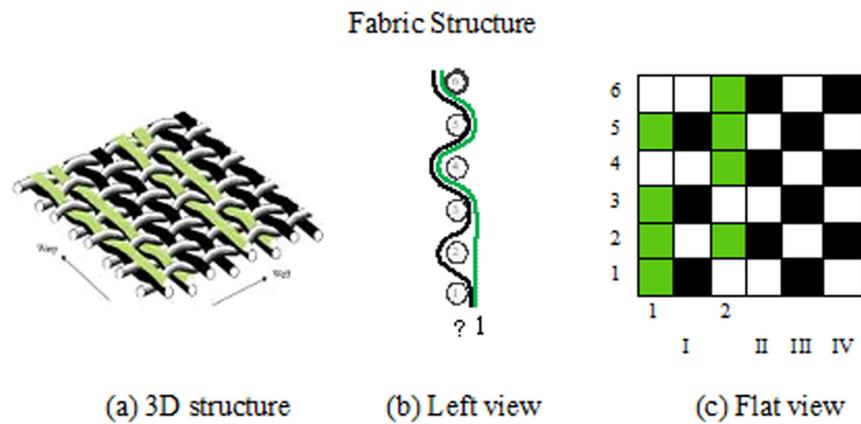
FIG. 26: The structure of the fabric is a ribbed-weave structure. It is a specially wave-backed weave consisting of two series of warp threads, face warp (green) and back warp (black), and one series of weft threads (white). The back warp interweaves with the wefts to form the back weave, which is 1-warp/1-weft, namely plain weave, while the face warps are over the plain weave, where every other two warps form the face weave, which is 3-warp/1-weft, 1-warp/1-weft twill. The special warp-backed weave gives different surface aspects to the inside and outside of the fabric tube.

the face weave, which had three warps: 10-weft/1-warp/1-weft twill. The special warp-backed weave provided different surface aspects to the inside and outside of the fabric tube. The back weave was taken as outflow side of the tube. This structure was designed to guarantee a better support the blood pulse pressure in the human body (Figures 26–30).

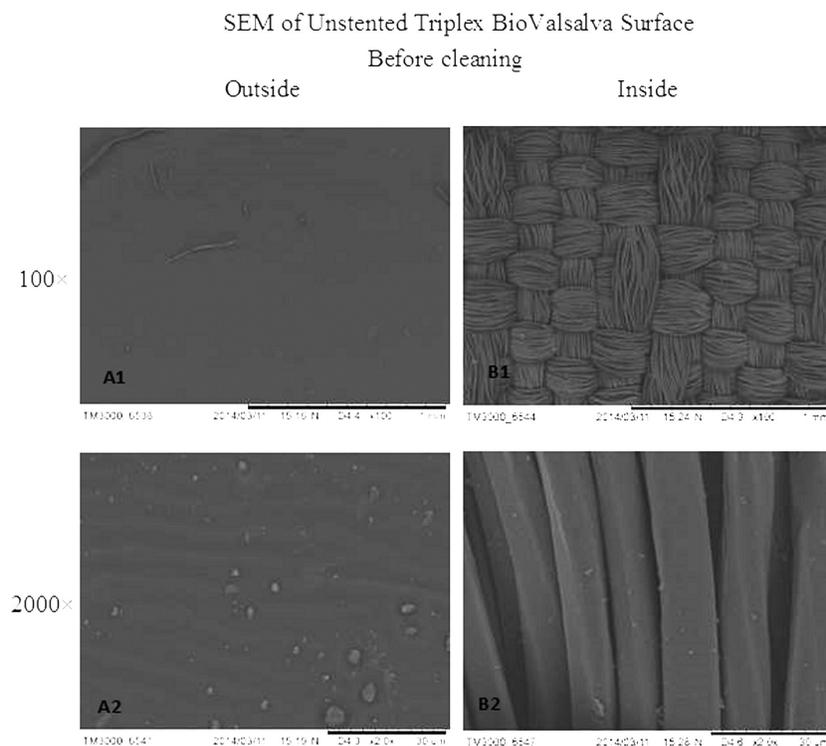
FIG. 27: Scanning electron microscopy of the inside and the outside of the unstented BioValsalva prosthesis. The external surface is smooth and glistening (A1:×100; A2:×2000). The structure of the polyester wave is clearly visible. This weave consists of two systems of warps (face warp and back warp). In this face weave, the face warp is interlaced with the left in the ruler of 3/3 twill with an interval of two warps (B1: ×100; B2:×2000).

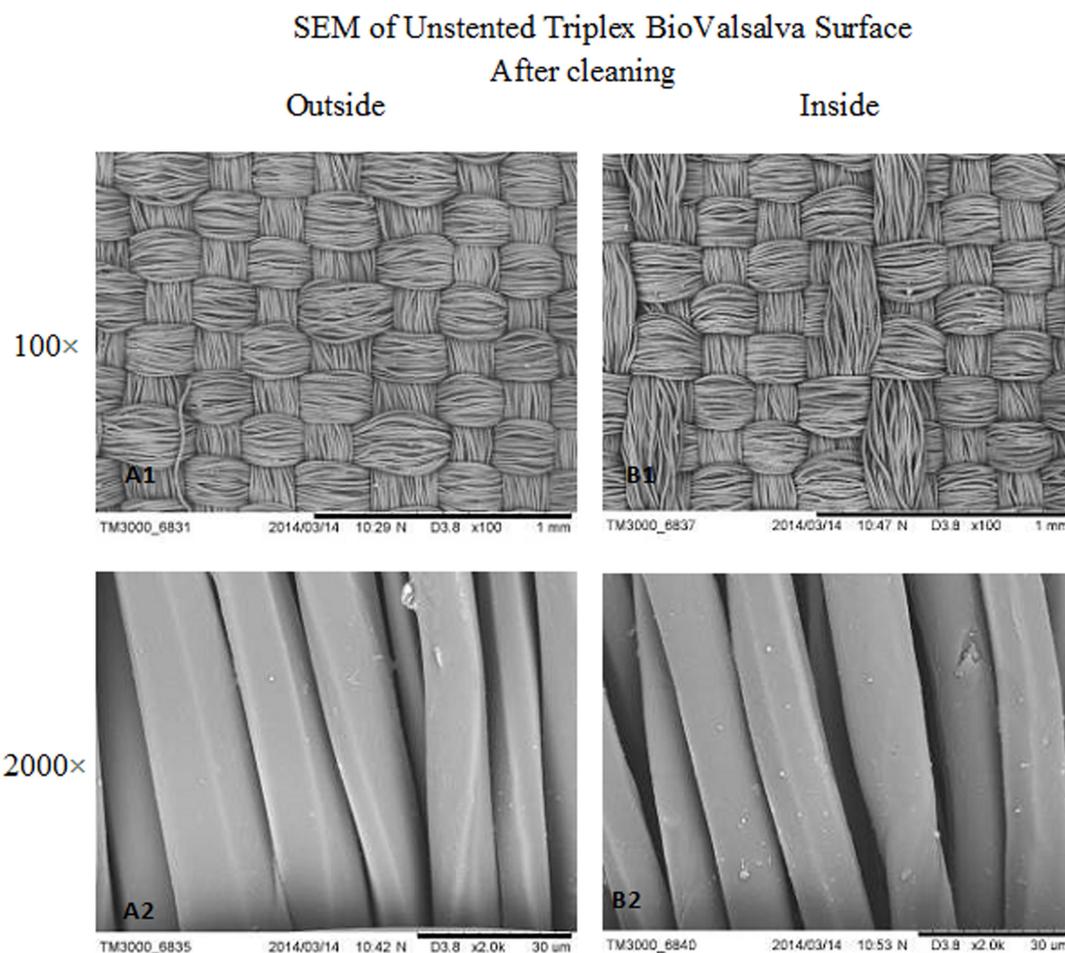
FIG. 28: Scanning electron microscopy of the inside and the outside of the unstented Biovalsalva prosthesis after cleaning. The side-by-side photos of the outside and the inside confirm that the weave of the polyester fabric (face warp and back warp) and one system of weft. The face weave is formed by interlacing face warp and weft. The back weave is formed by interlacing back warp and weft. The back weave is a traditional plain weave; in the face weave, the warp is interlaced with the weft in 3/3 twill with an interval of two warps.

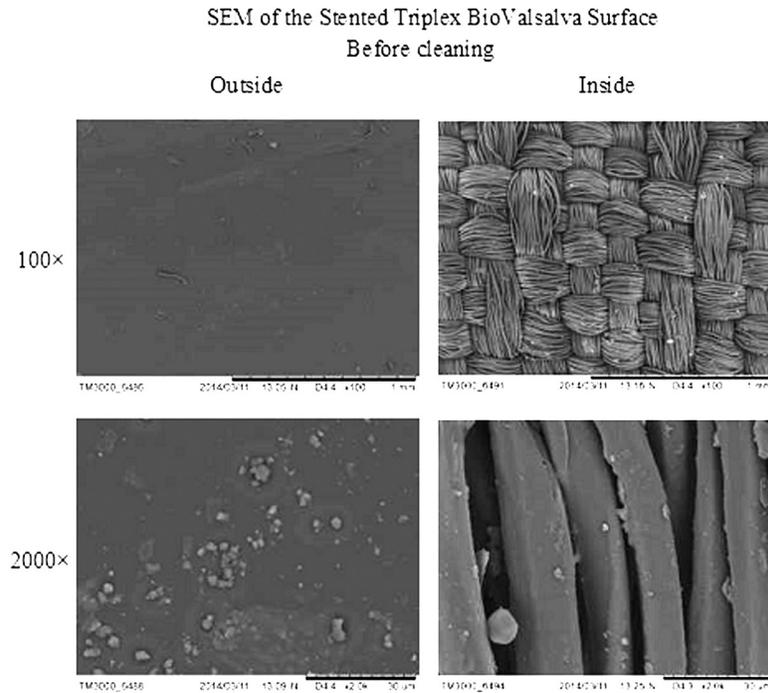
FIG. 29: Scanning electron microscopy of the outside and inside the of the stented BioValsalva prosthesis as received from the manufacture. Both the outside and the inside observation are similar to those of the unstented device.

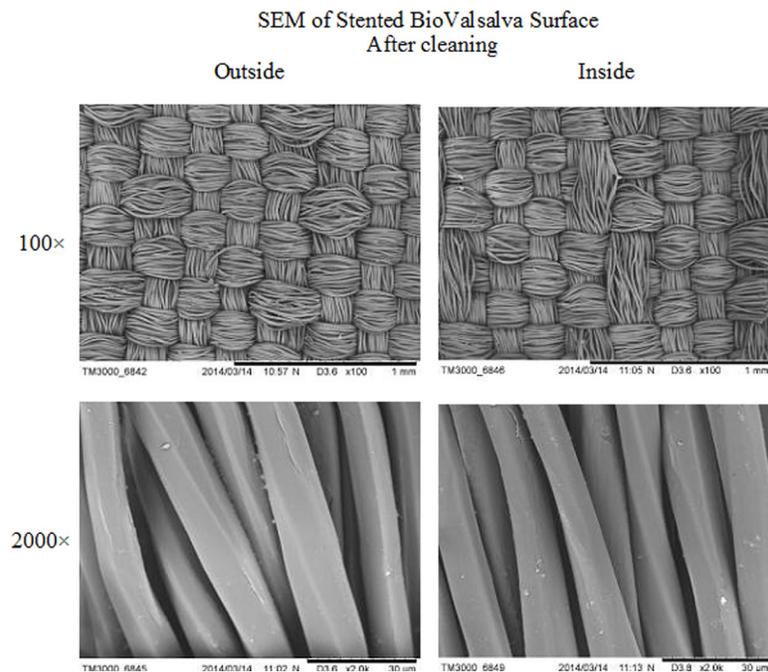
FIG. 30: Scanning electron microscopy of the outside and inside of the stented BioValsalva prosthesis after cleaning and eliminating the external coating. The structure of the polyester fabric was identical to the one observed in the unstented device.

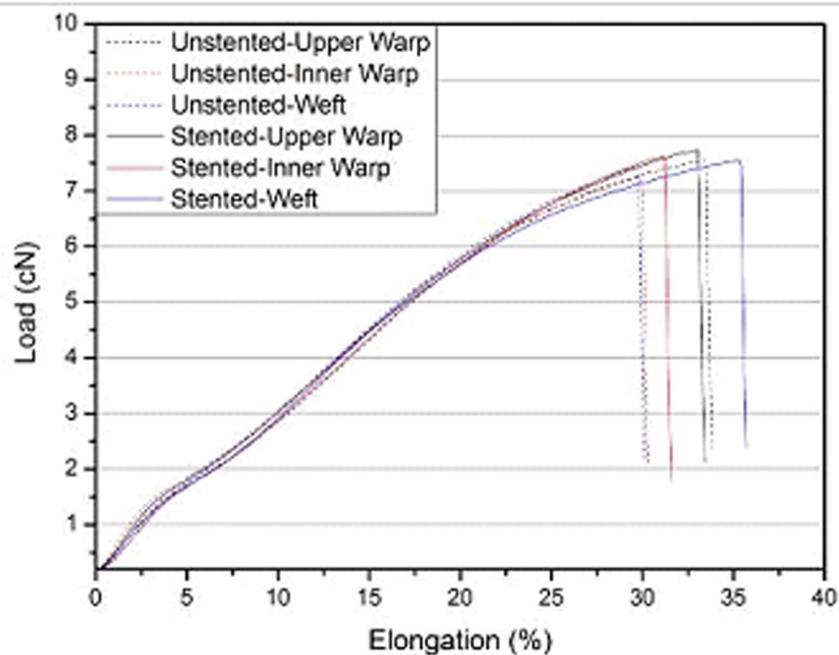
Load-Elongation Curve of the Filaments

FIG. 31: Load elongation curve of the filaments. For each kind of yarn (upper warp, inner warp and weft, both on unstented and stented devices), 20 filaments were chosen randomly from 10 different yarns for the filament tensile test. The data presented in the table are the mean value of the 20 times tests.

the filament linear density were calculated values according to the measuring diameter of filament (Table 2). The stretch-strain behaviors of the filaments at both warp and weft directions of the stented and unstented fabrics are presented in Figure 31. The filaments typically exhibited a linear behavior below 3% of elongation, which likely represents the elastic deformation. Creep occurred at ~5% of elongation, followed by a long and almost linear increase of stress with strain before reaching ultimate failure between 30 and 35% of elongation. This final segment of plastic deformation is likely associated with sliding among the oriented macromolecules and stress-induced crystallization as well. All tested filaments recorded similar stress-strain behaviors except differences in the ultimate elongation.

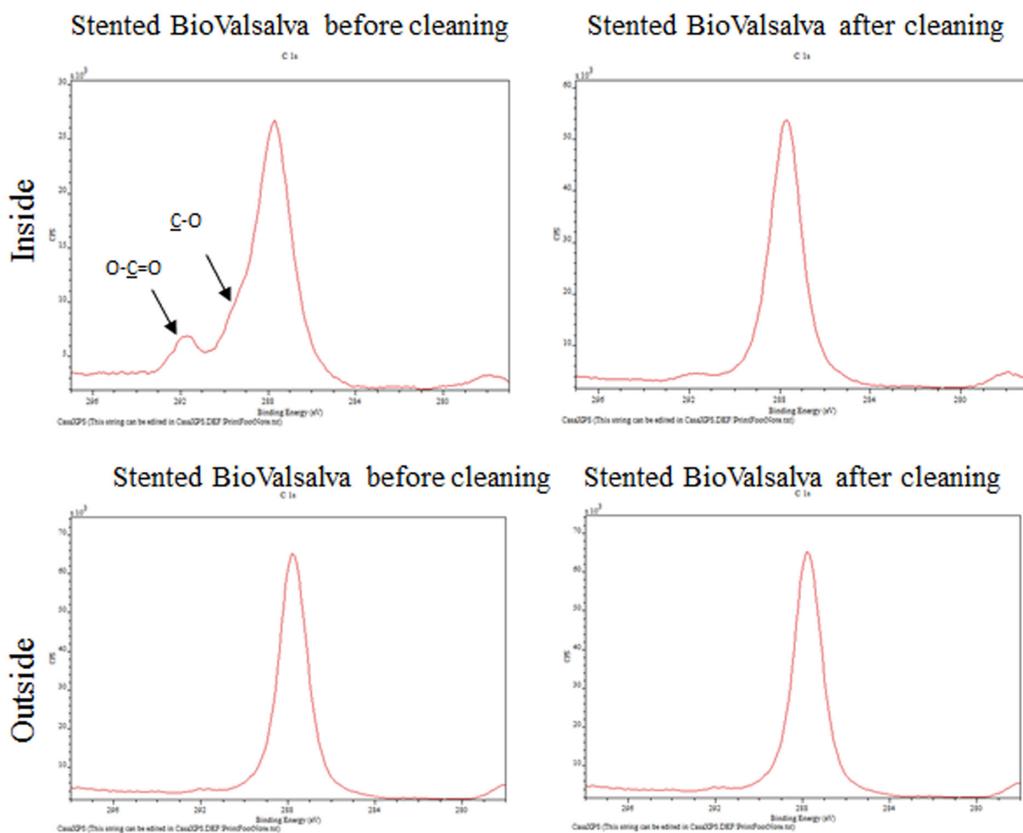
FIG. 32: High-resolution C_{1s} spectra of the BioValsalva prostheses measured with XPS, showing the distinct presence of oxygen moieties inside the non-cleaned fabrics, and the similar spectra after cleaning.

Table 3 lists the surface elemental composition on both sides of the stented fabrics before and after cleaning with the high-resolution C_{1s} spectra (Figure 32). Before cleaning, the inside clearly differs from outside in carbon, oxygen, and silicon contents, showing much higher oxygen and silicon contents but lower carbon content. The difference disappeared after cleaning because of the reduced oxygen and silicon on the inside. Such changes before and after cleaning were also found on the unstented fabrics (data now
