The Triplex BioValsalva Prostheses To Reconstruct the Aortic Valve and the Aortic Root

ABSTRACT: The Bentall procedure introduced in 1968 represents an undisputed cure to treat multiple pathologies involving the aortic valve and the ascending thoracic aorta. Over the years, multiple modifications have been introduced as well as a standardized approach to the operation with the goal to prevent long-term adverse events. The BioValsalva prosthesis provides a novel manner to more efficiently reconstruct the aortic valve together with the anatomy of the aortic root with the implantation of a valved conduit. This prosthesis comprises three sections: the collar supporting the valve; the skirt mimicking the Valsalva, which is suitable for the anastomoses with the coronary arteries; and the main body of the graft, which is designed to replace the ascending aorta. The BioValsalva prosthesis allows the Bentall operation to be used in patients whose aortic valve cannot be spared.

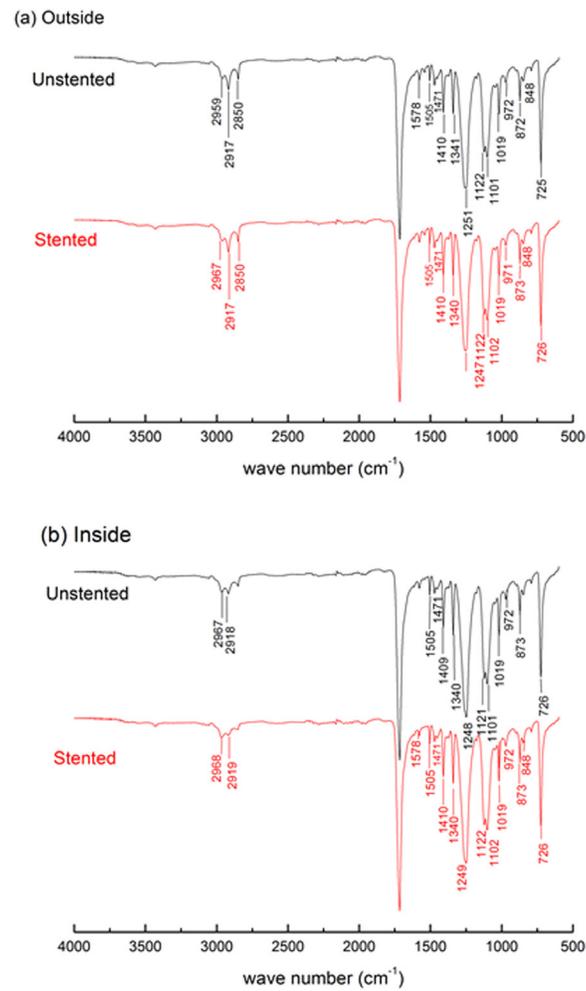
FTIR of the Blood Conduits (after elimination of the coating)

FIG. 34: FTIR of the outside and the inside of the blood conduit of the BioValsalva prosthesis after digestion of the coating.

side surface is SEPS (styrene ethylene propylene styrene block copolymer). Compared with the spectrum of the outside of the devices after elimination of the coating (Figure 34a), the conclusion that the coating has been completely removed can be drawn.

33b). The spectrum after cleaning was almost the same as those prior to cleaning, suggesting that no major surface chemical change occurred following cleaning (Figure 34b).
